PROCTOR/DAVIS/RAY

Re: Maxwell H. Gluck
Equine Research Center
University of Kentucky

We have gone back over all of the punch lists which we had made on mechanical and electrical work for this project and the following is the listing of those items that are still not satisfactory.

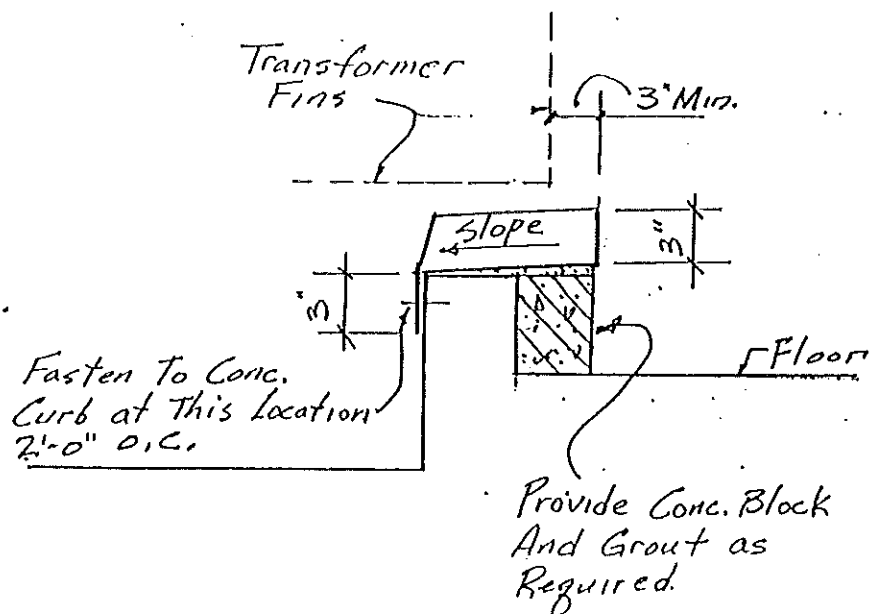
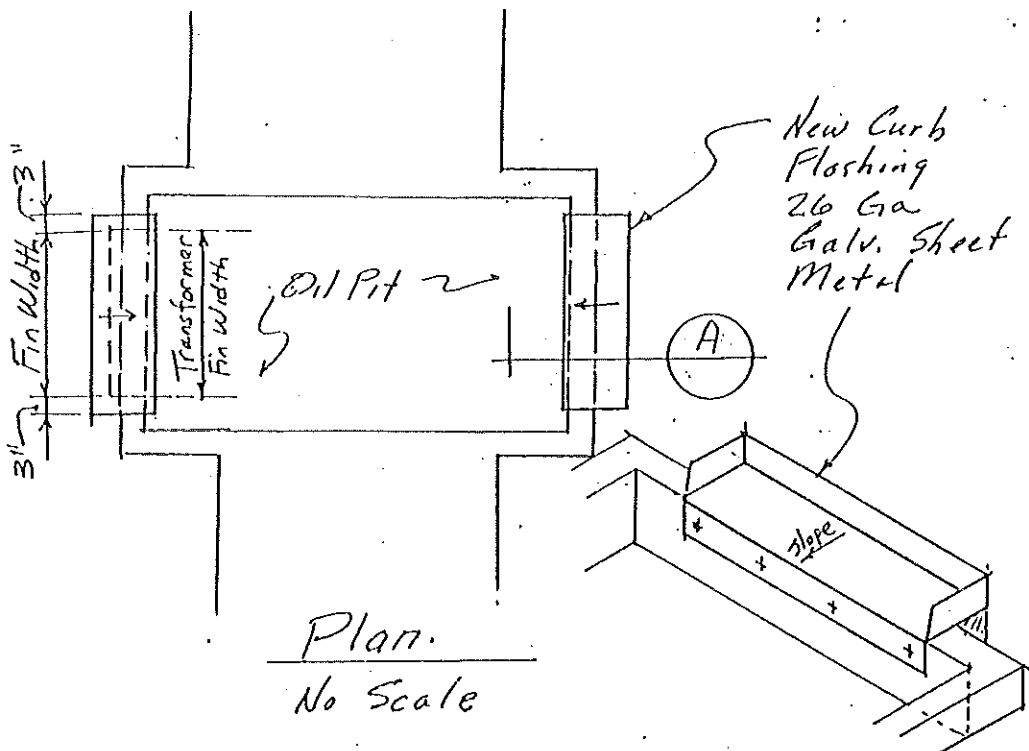
DETAIL "A"

Transformer pit sheet metal flashing not installed properly. Re-install
as shown on attached supplemental drawing.
